RECREATIONAL BOAT SAFETY  
COLLISION RESEARCH

PHASE I

VOLUME I - PROBLEMS DEFINITION

September 1975

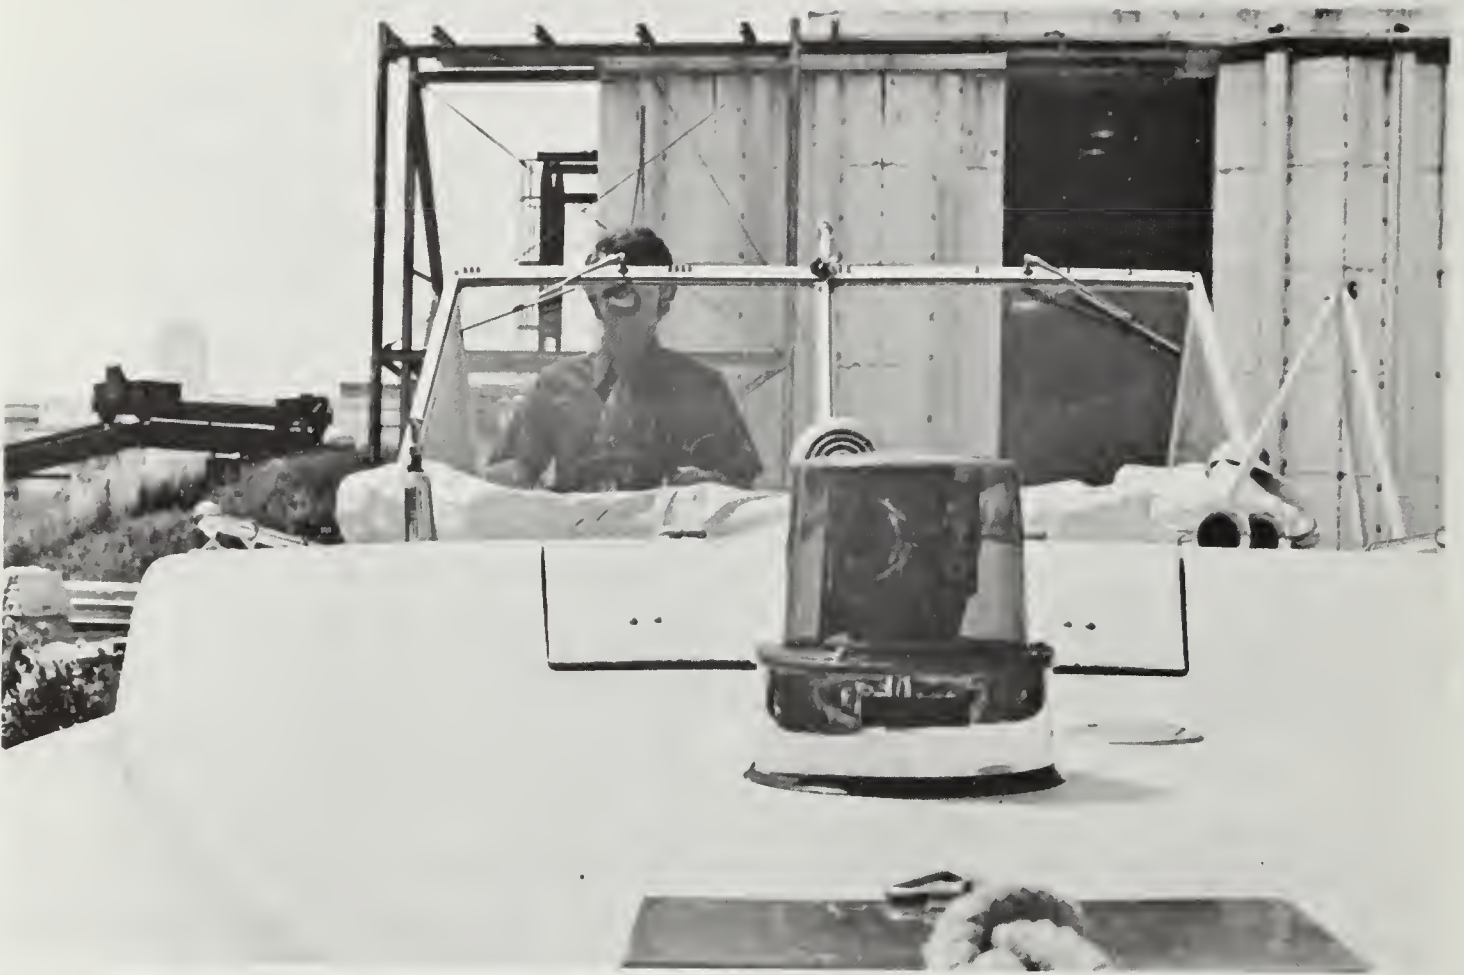
Figure 3-2. Wiper Motor Caused Visibility Problem

Windshield wipers are optional equipment on most runabouts and small cruisers and as such are afterthoughts. Windshield wiper motors frequently are so located that they obstruct the view of the operator. Figure 3-2 shows the wiper motor on a Coast Guard patrol boat. In

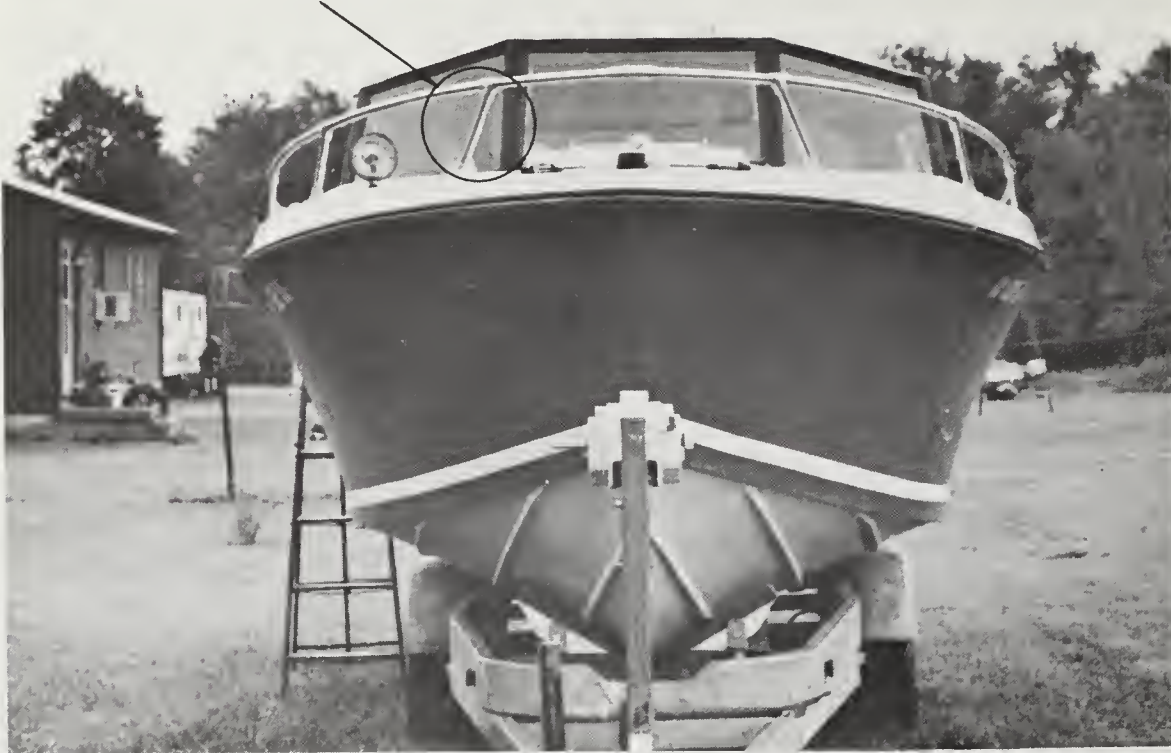
Figure 3-3. Visibility Problems

Note how windshield post, dark tinted windshield and rail obscure view.  
Operator's head almost invisible.

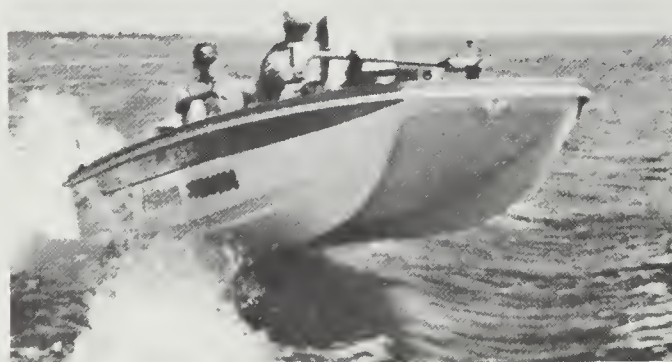
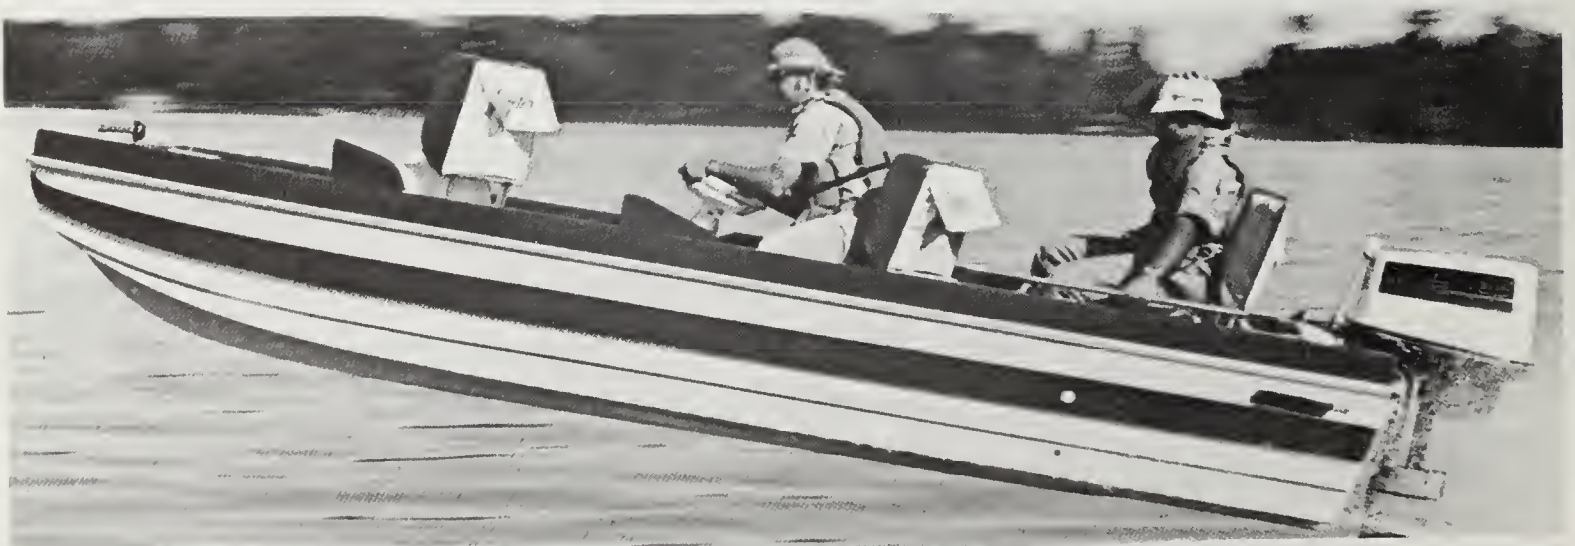
Figure 3-4. Visibility Problems - Bass Boats

3.3.1.2.3 Other Objects in the Field of View — Boat manufacturers as well as owners tend to mount large objects to the boat forward of the helmsman in such a way that some portion of his forward field of view is obscured. Bass boat manufacturers mount plush, high backed upholstered armchairs on pedestals forward of the control station. If the chair is turned sideways and locked, the operator can gain visual access to the water on the other side of the back of the chair by moving his head back and forth. However, if the chair is facing forward, as it would be naturally if the brake weren't tightened, some portion of the operators forward field of view is permanently obscured. See Figure 3-4.

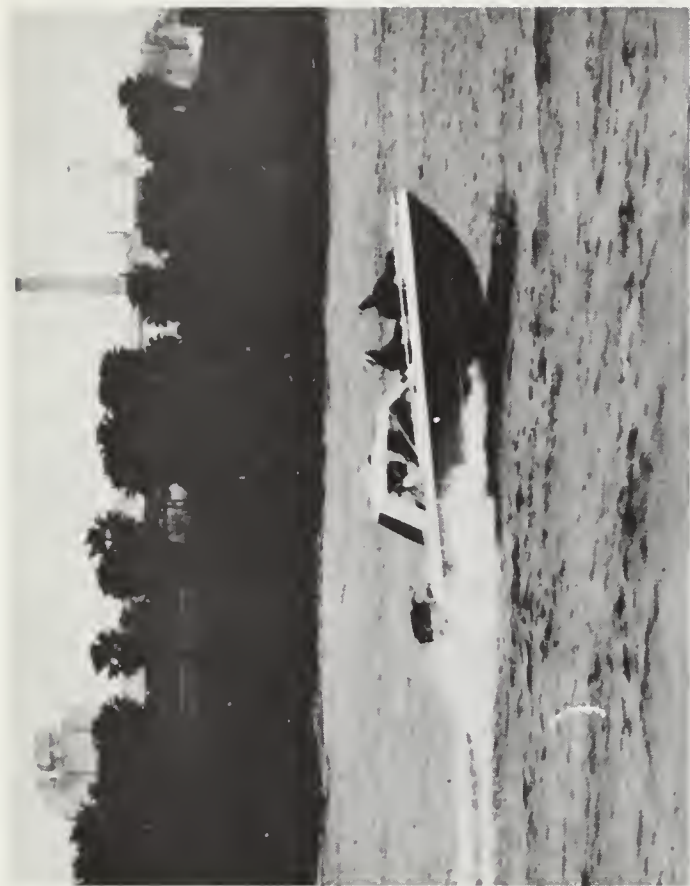
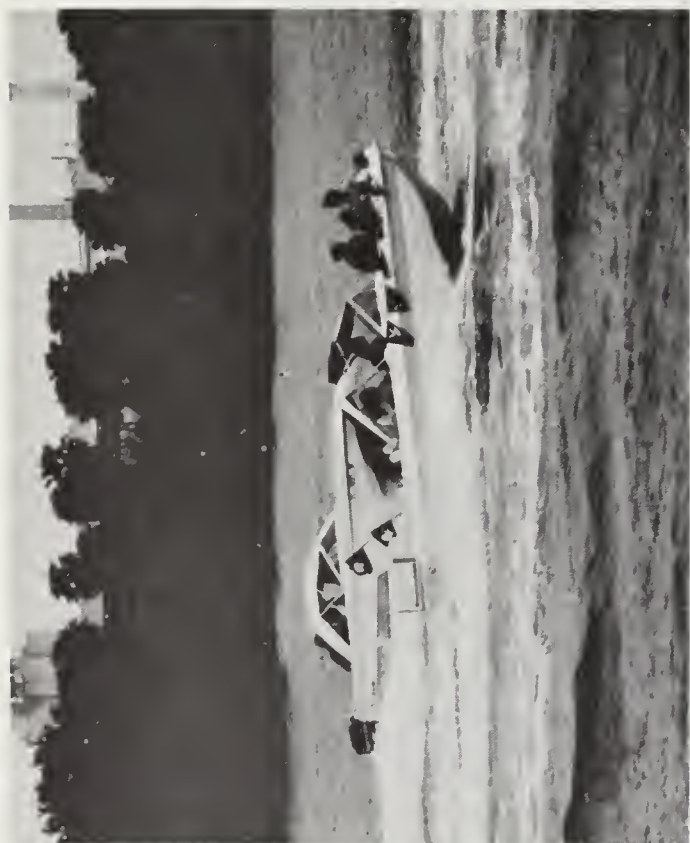
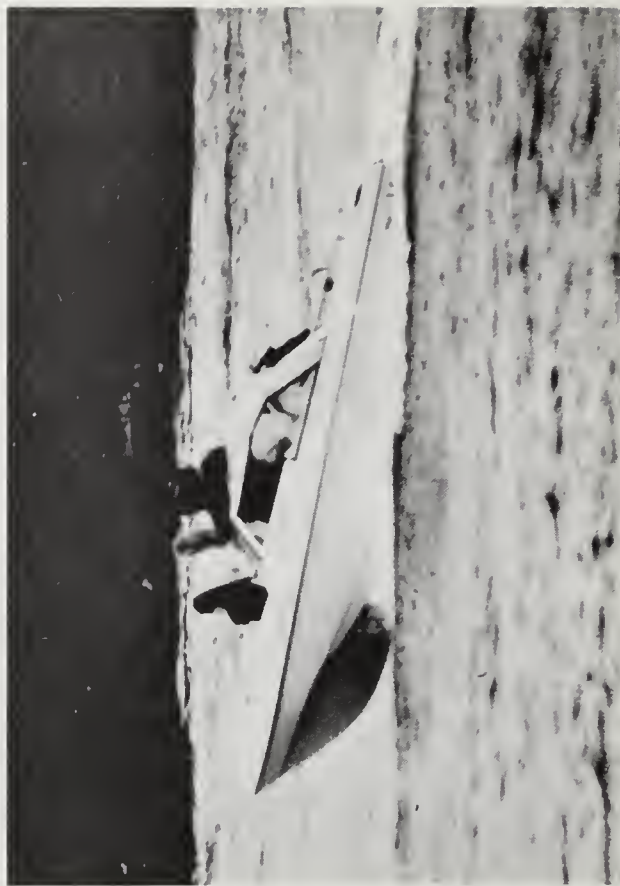
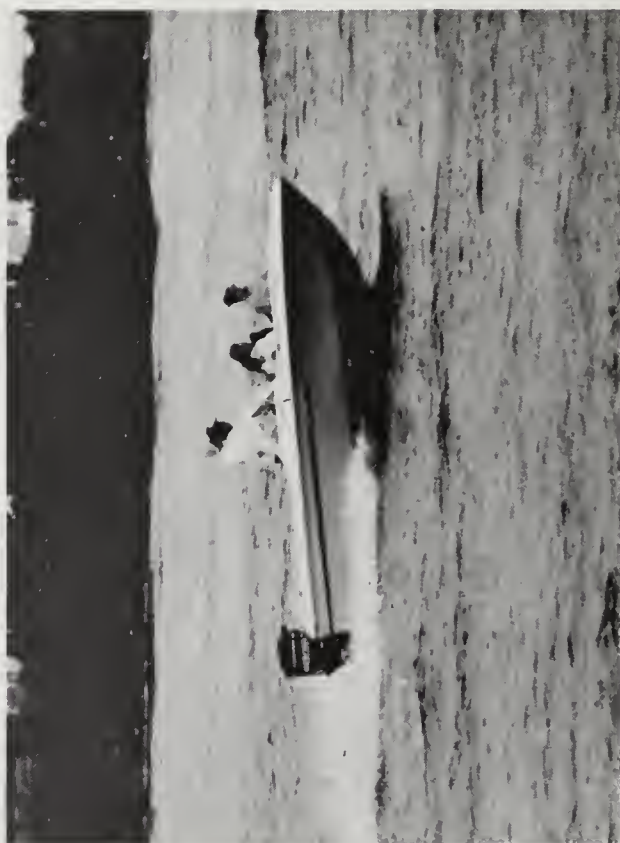
Figure 3-5. Visibility Problems - Bowriders

Figure 3-5 shows four bowrider boats with people forward. In the top two photos, the operators are seated and in the case of the boat on the right, the seated operator probably cannot see the horizon over the bow. The operators in the bottom two photos are standing and looking over the heads of the people sitting forward. When there is no top as is the case with the boat on the bottom left, the operator may stand directly behind the wheel; however, notice that the operator in the boat on the right is standing in the middle of the boat with the upper portion of his body protruding through the opening in the center of the canvas top. The problem here is not one of visibility. In fact the operator has compromised other safety aspects in order to gain visibility. By standing in the middle of the companionway, he has moved completely away from the control station. From that position the shift and throttle controls cannot be reached. If the situation developed wherein he had to maneuver quickly in order to avoid a collision, he would have to first duck down and under the canvas top, sit behind the wheel or reach across the seat to manipulate the control handles. When

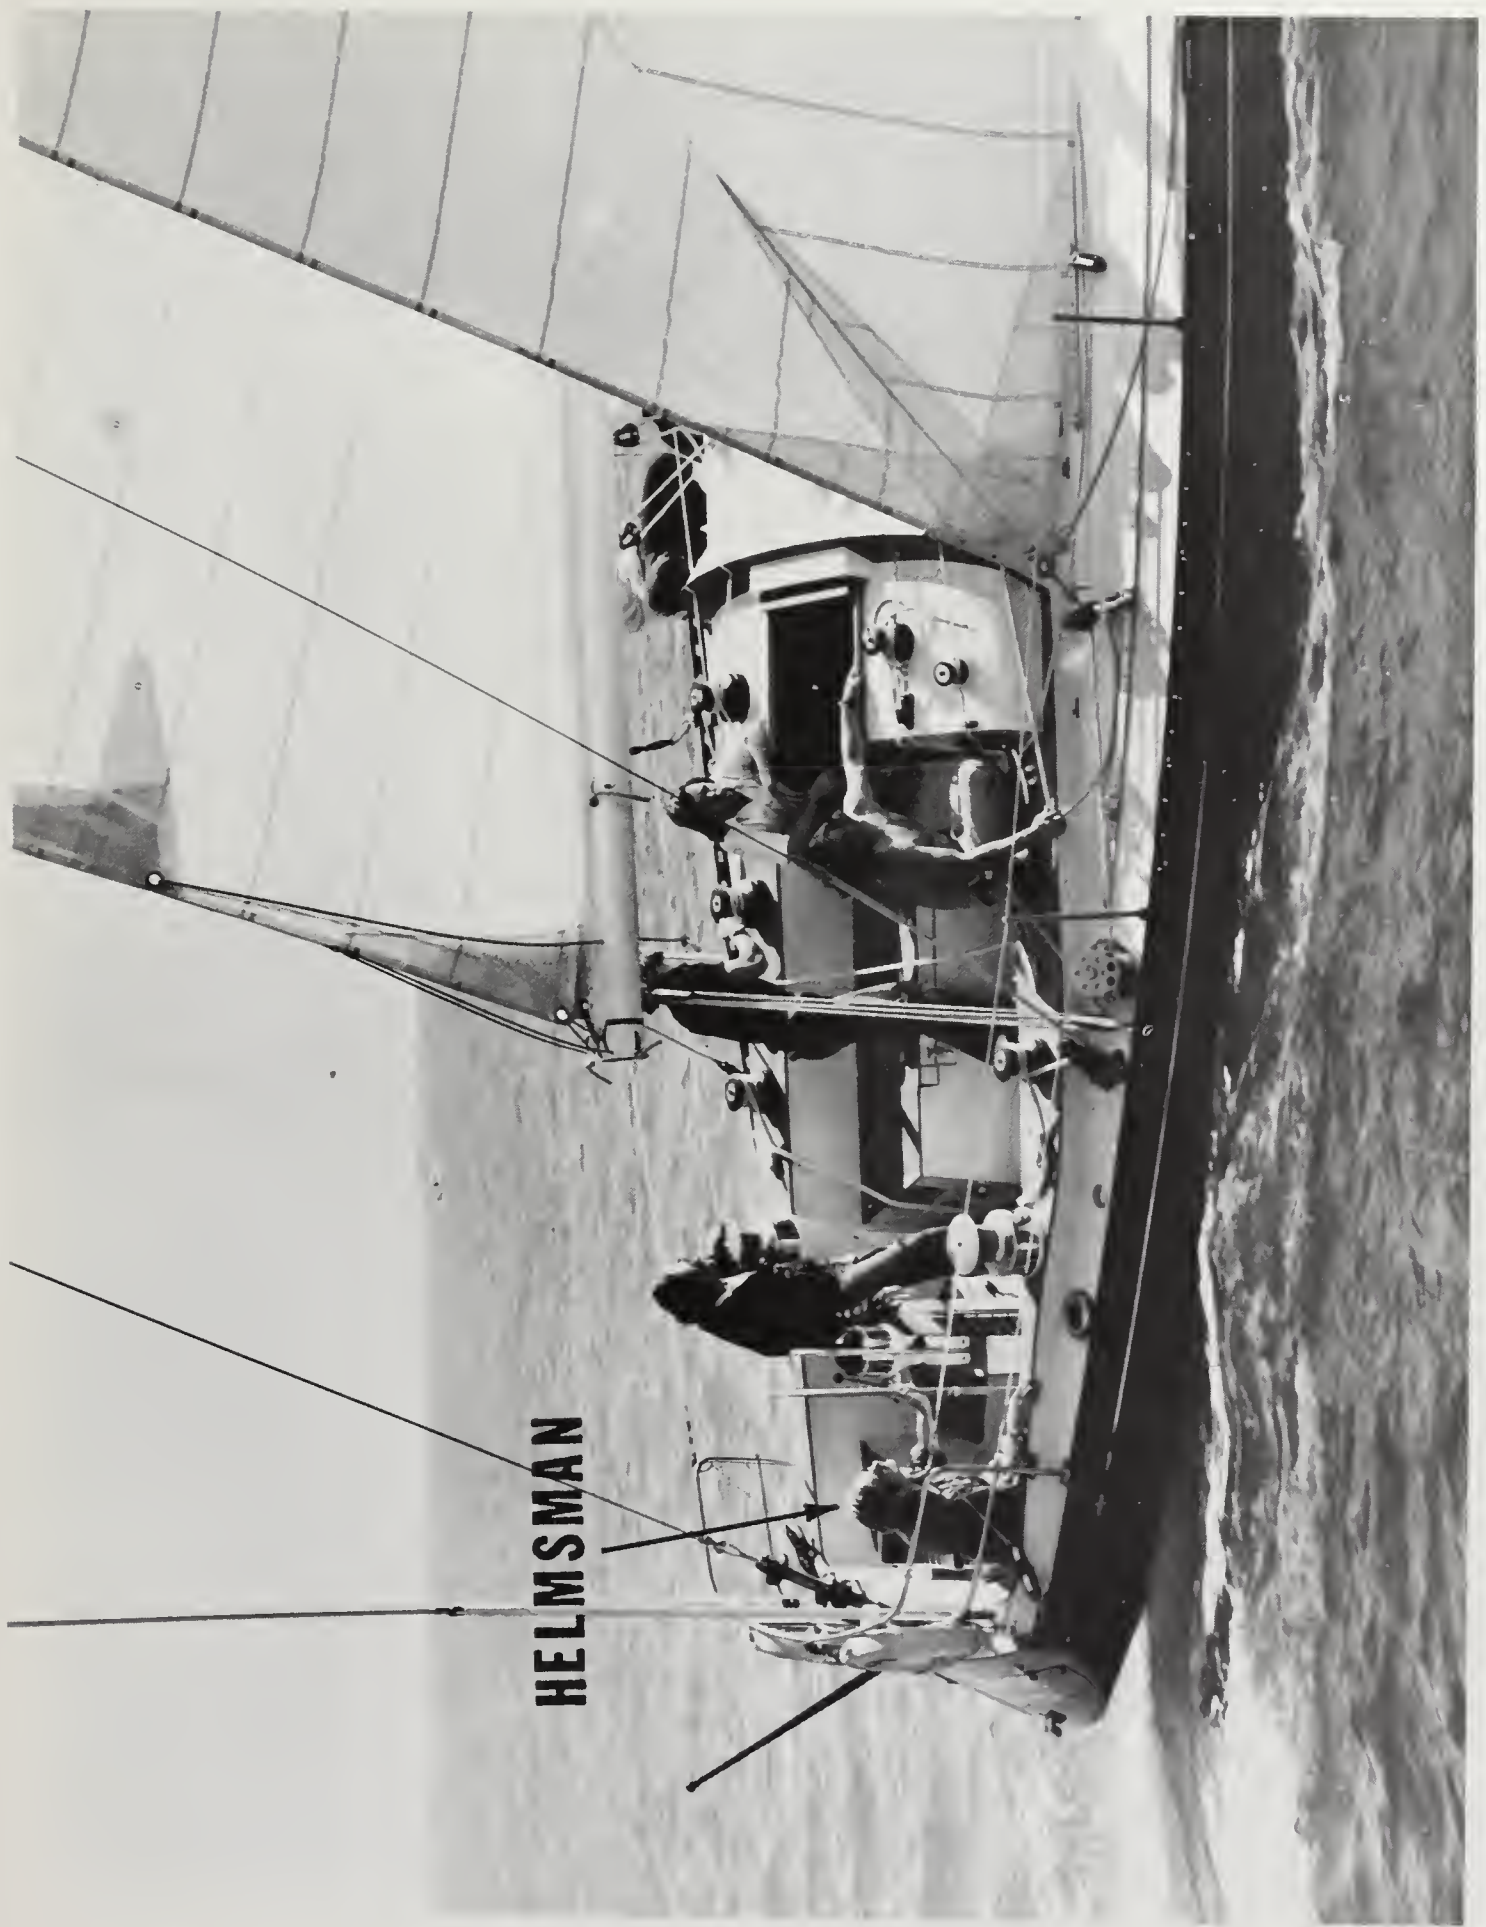
Figure 3-6. Visibility Problems – Sailboats

He can't see forward or leeward because of the Genoa. Therefore, an observer sitting to windward must keep the helmsman informed of objects or boats in his path and the best course of action to be taken. See Figure 3-6.

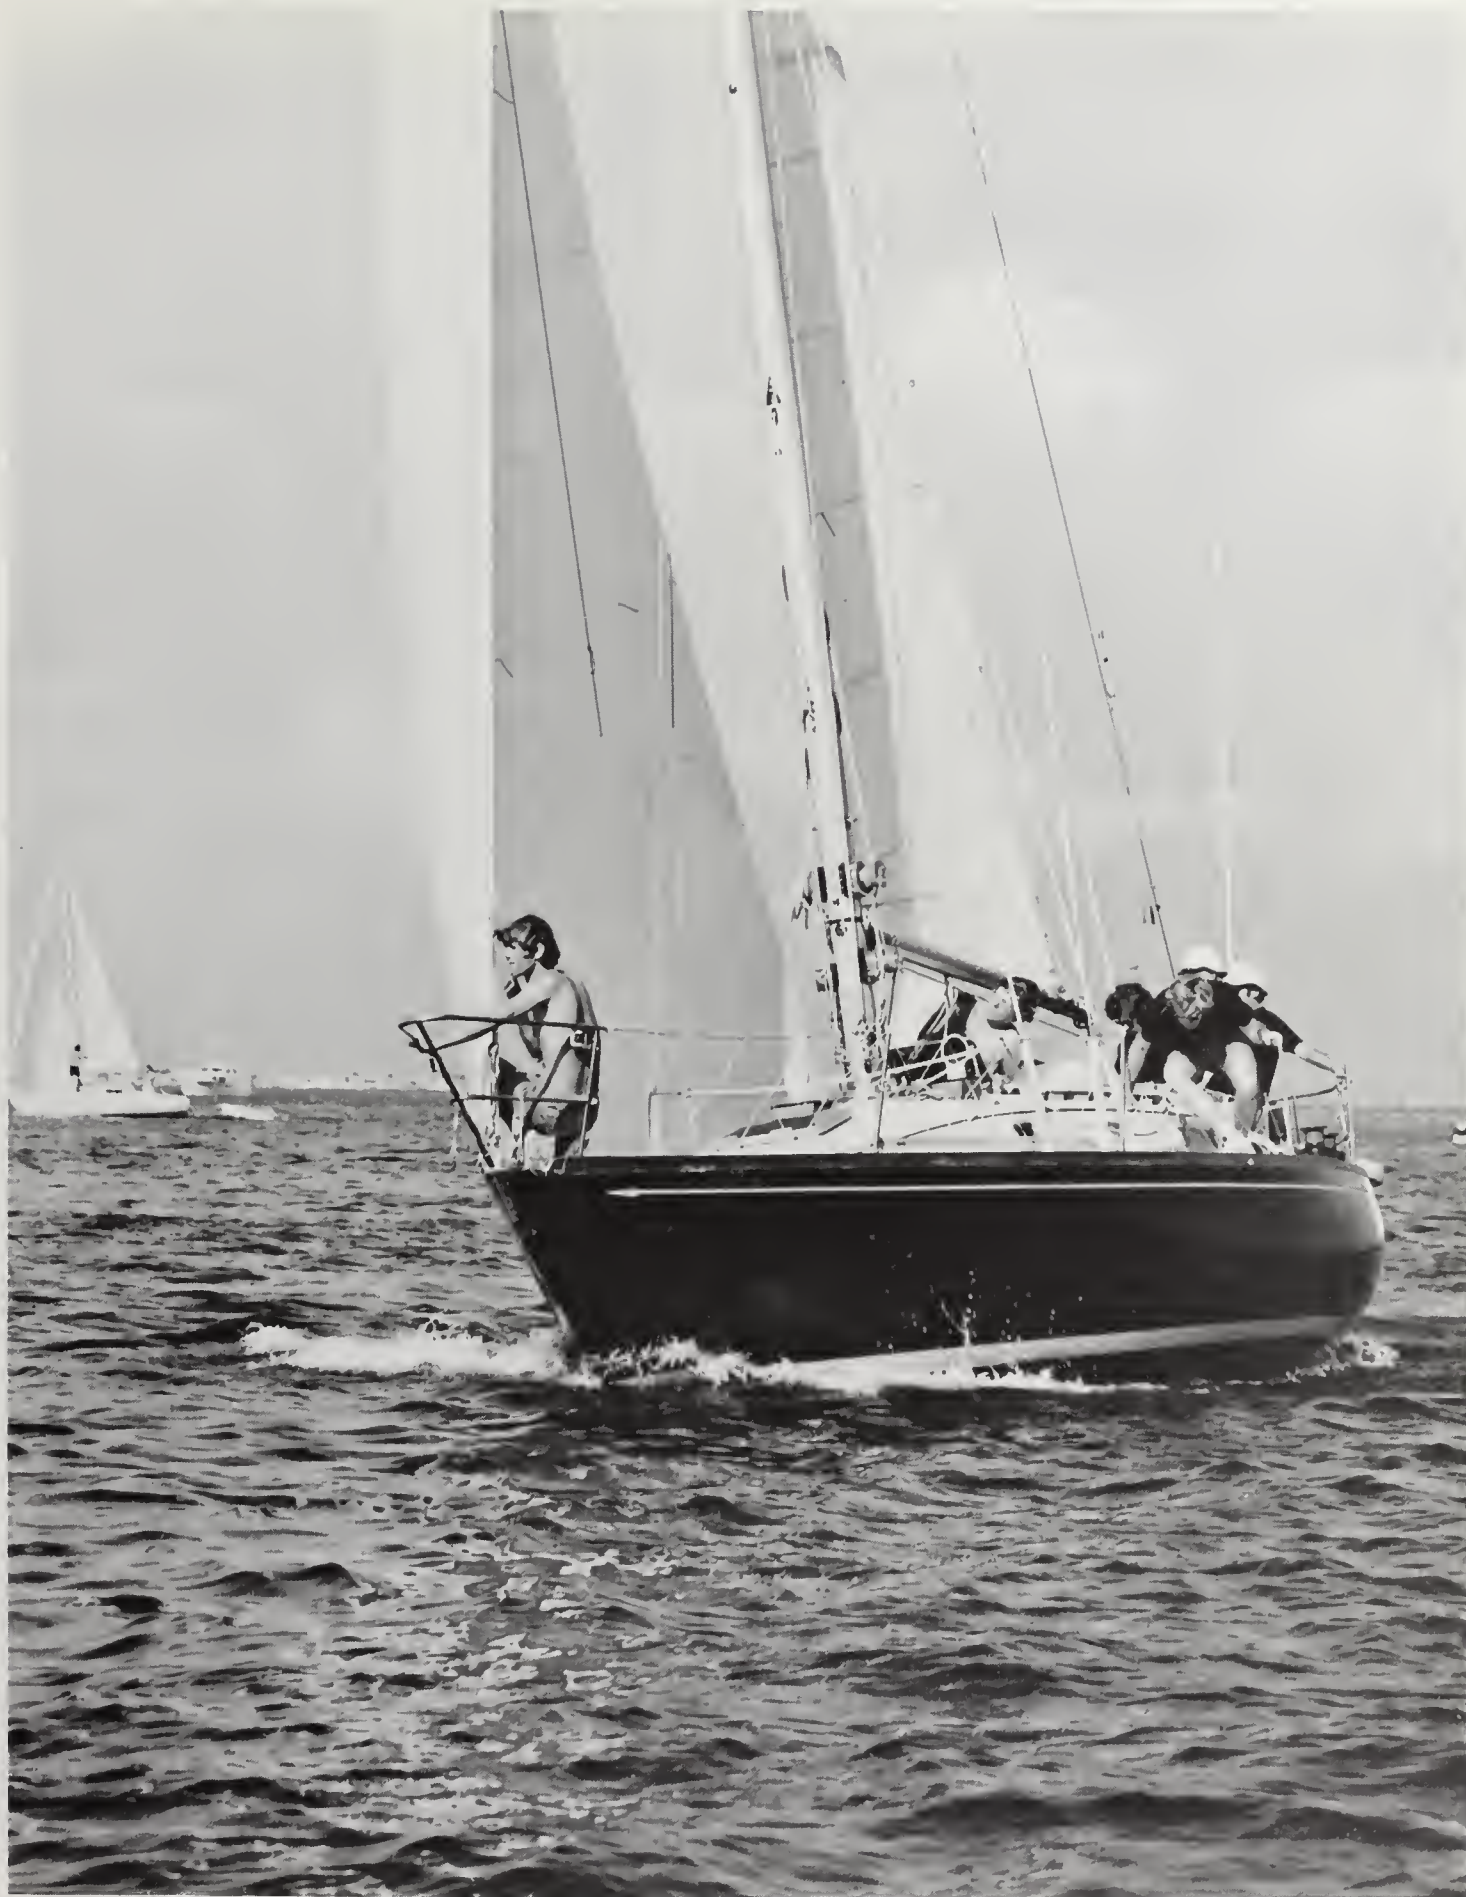
Figure 3-7. Visibility Problems - Sailboats

The headsails and specifically the Genoa's of large sailboats are often designed to almost touch the deck when the boat is tacking close to the wind. Since the No. 1 Genoa often extends to or even past the forward portion of the cockpit, helmsman visibility is again severely limited. Collision No. 85 happened because two large sailboats were on converging courses but were both obscured from the helmsman's view by their large Genoa's. Figure 3-7

shows a cruising boat heading more or less towards the camera. It is interesting to note that the helmsman is not visible from a position forward of his boat. Therefore, he can't see forward. In fact, there is a "bow watch" stationed forward to warn the helmsman of impending dangers. Also see Figure 3-8. Here, a crew member has lifted a portion of the Genoa to look for other boats.

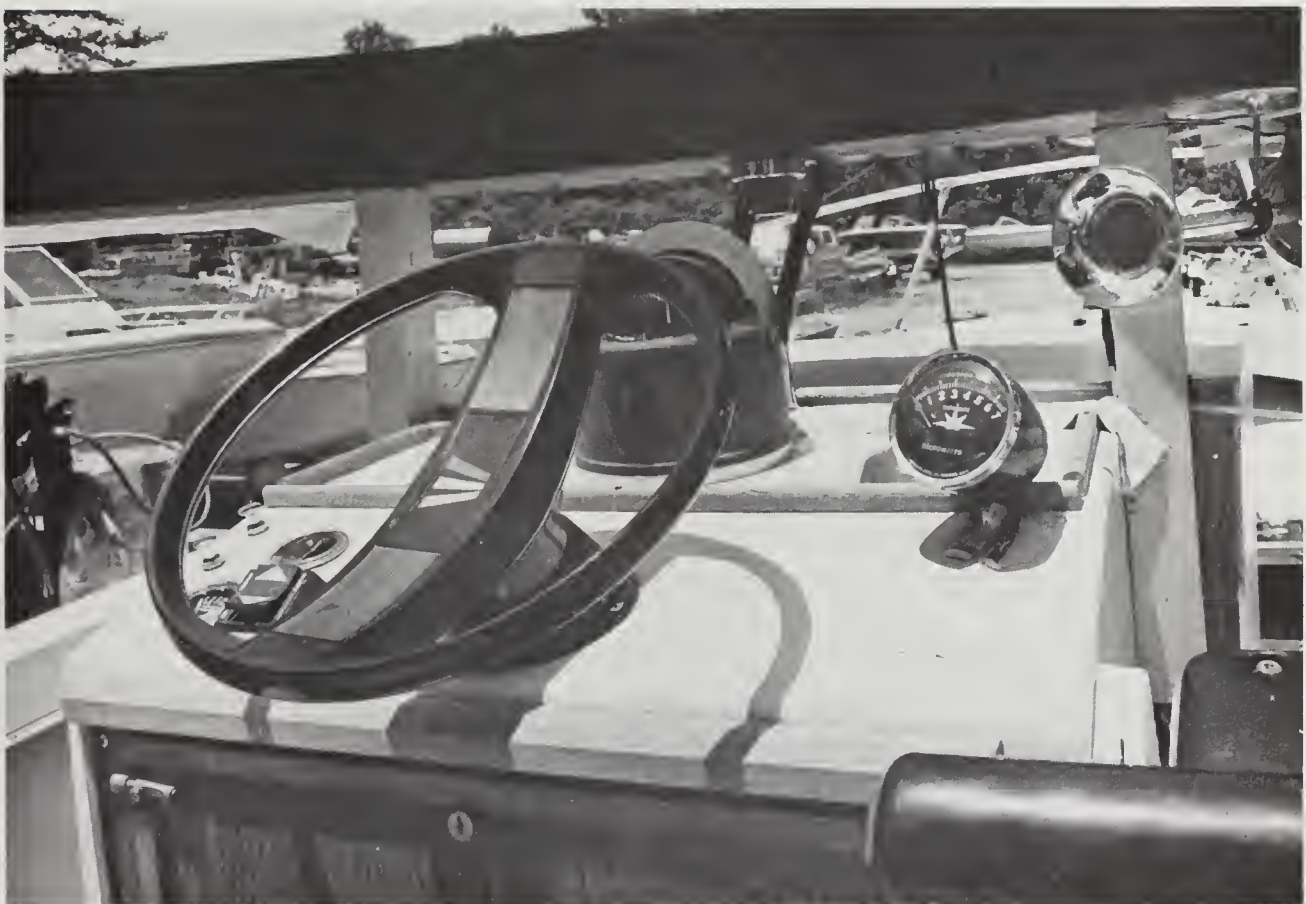
Figure 5. Control Station Area

Figure 5 shows the cockpit area as viewed from behind the throttle handle. The horn in the upper right of the photograph was used to signal the subject that he was off course. Below and just to the left of the horn is the tachometer. The subject was instructed to maintain a setting of 4000 rpm on this instrument but was allowed to change speeds in order to avoid other boats and bridges, to execute a course change, or to slow down if the wave conditions would not permit running at that speed. Directly in front of the steering wheel is the compass. The experimenter verbally called out course headings which the subject tried to maintain. The horn was blown at the experimenter's discretion. His tolerance was based upon the present conditions, the subject's responses (was he trying to get on course?), and our estimates from the training trials that most subjects could maintain a heading within 5 degrees.

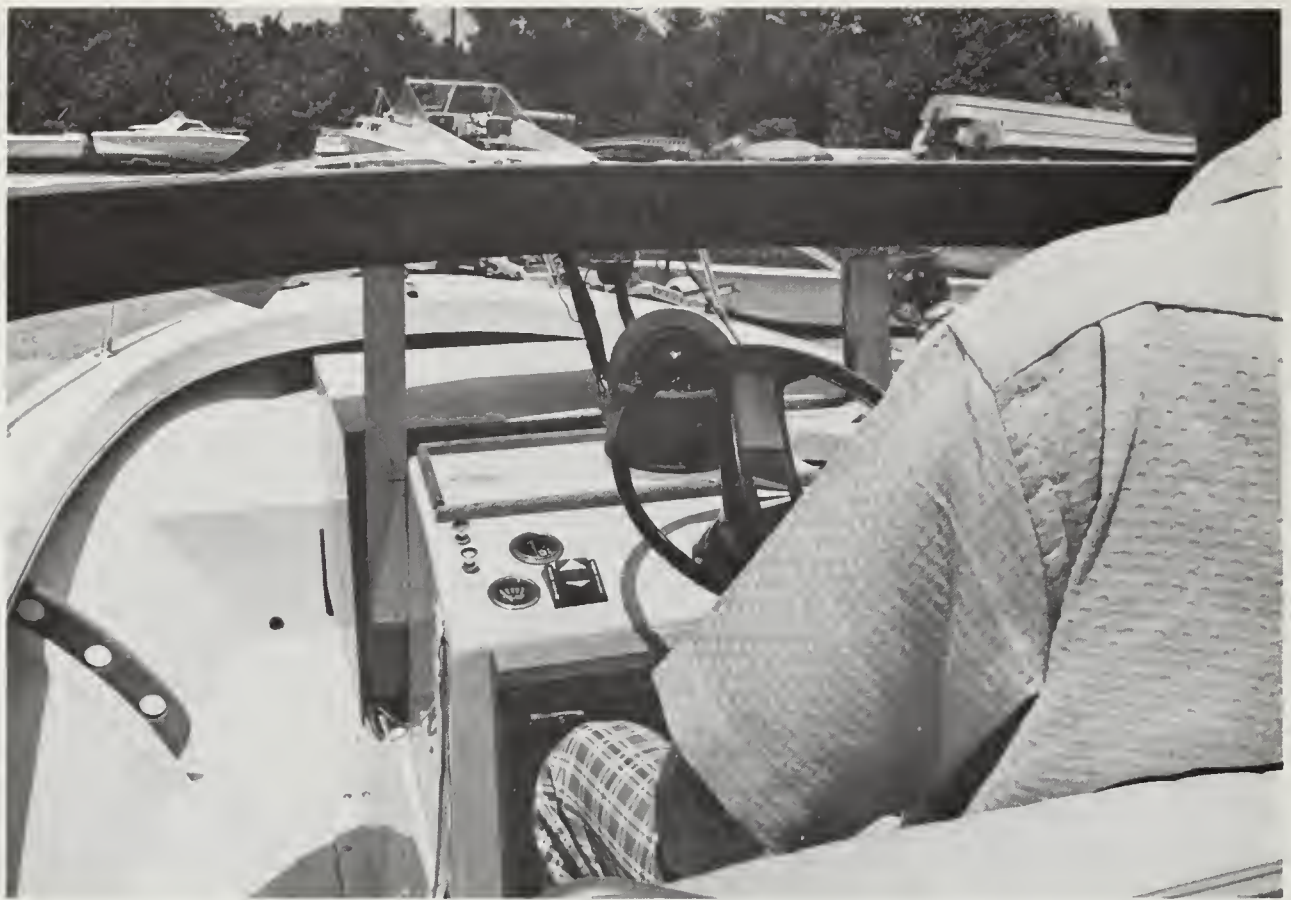
Figure 6. View Over Subject's Left Shoulder

Figure 6 shows the cockpit area as seen from over the subject's left shoulder. The steering wheel, compass, program interrupt light, and light display ring are all clearly visible. The controls to the left of the steering wheel are the real power trim switch and other boat controls and displays.

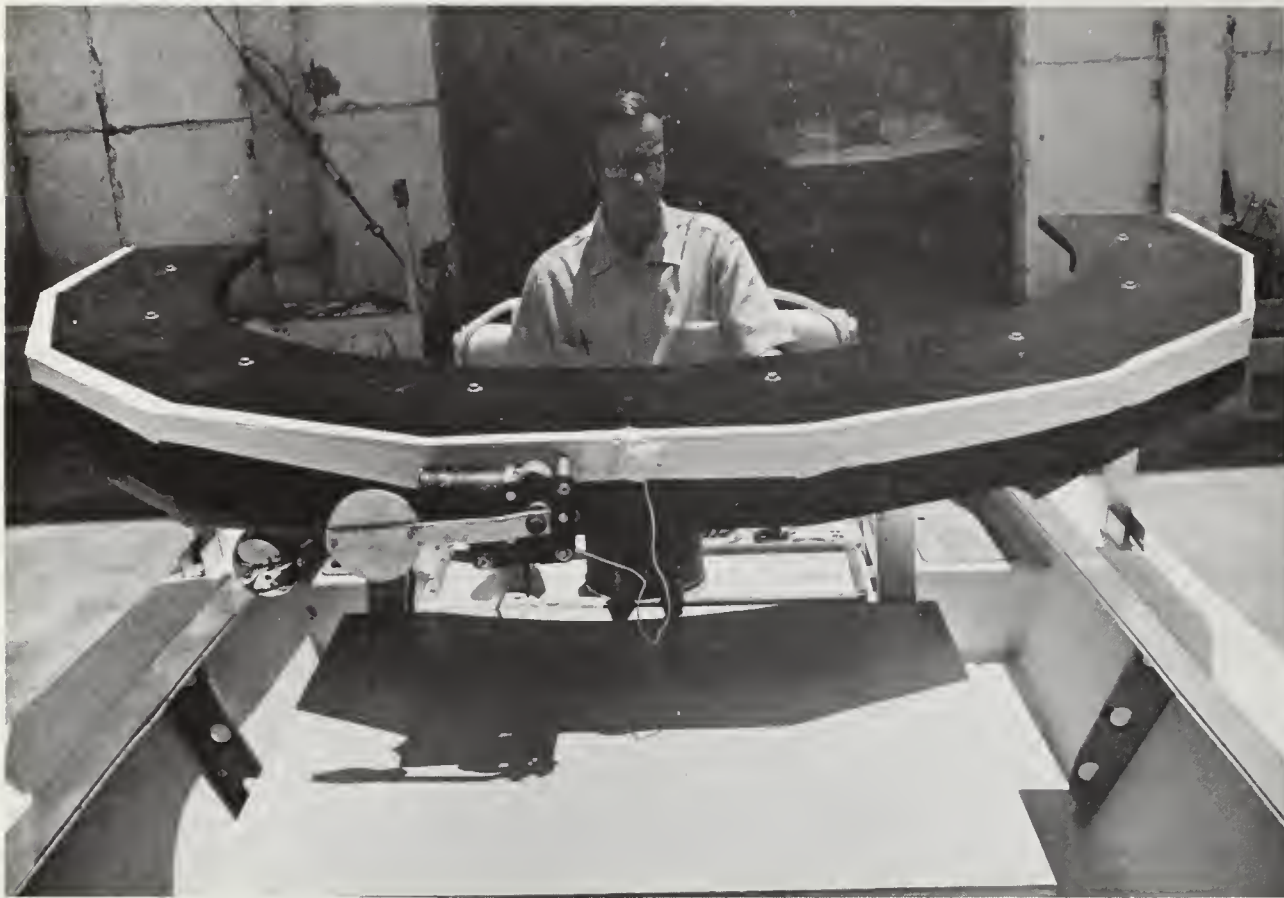
Figure 8. VAST Apparatus Viewed From Bow

Figure 8 is an aft-facing view of the cockpit and subject. In the foreground is the plywood cover to the computer and recorder. The picture also shows the extent of the light display ( $190^{\circ}$ ) and the visibility of the subject. The display is within a few degrees of the line of sight over the bow.

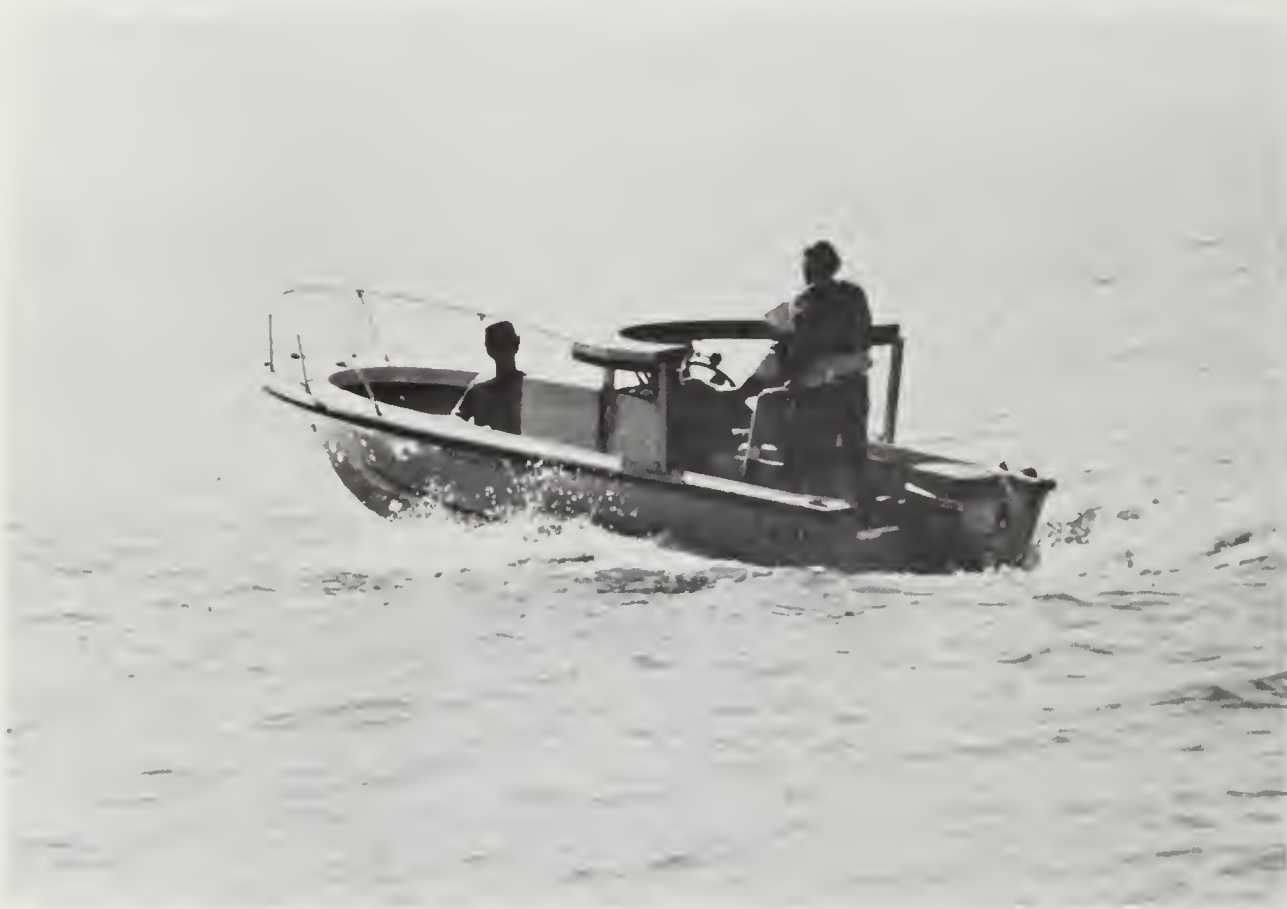
Figure 9. VAST Experiment Underway

Figure 9 is a photograph of the VAST boat in action off the coast of Sanibel Island, Florida. The picture was taken during part of the fatigue cycle for the subject in the bow. The photograph shows the boat during the VAST test (although no lights were visible at this point) with the experimenter and subjects in their "running" positions. The cartoon in Figure 10 captures the essence of the afternoon fatigue runs.

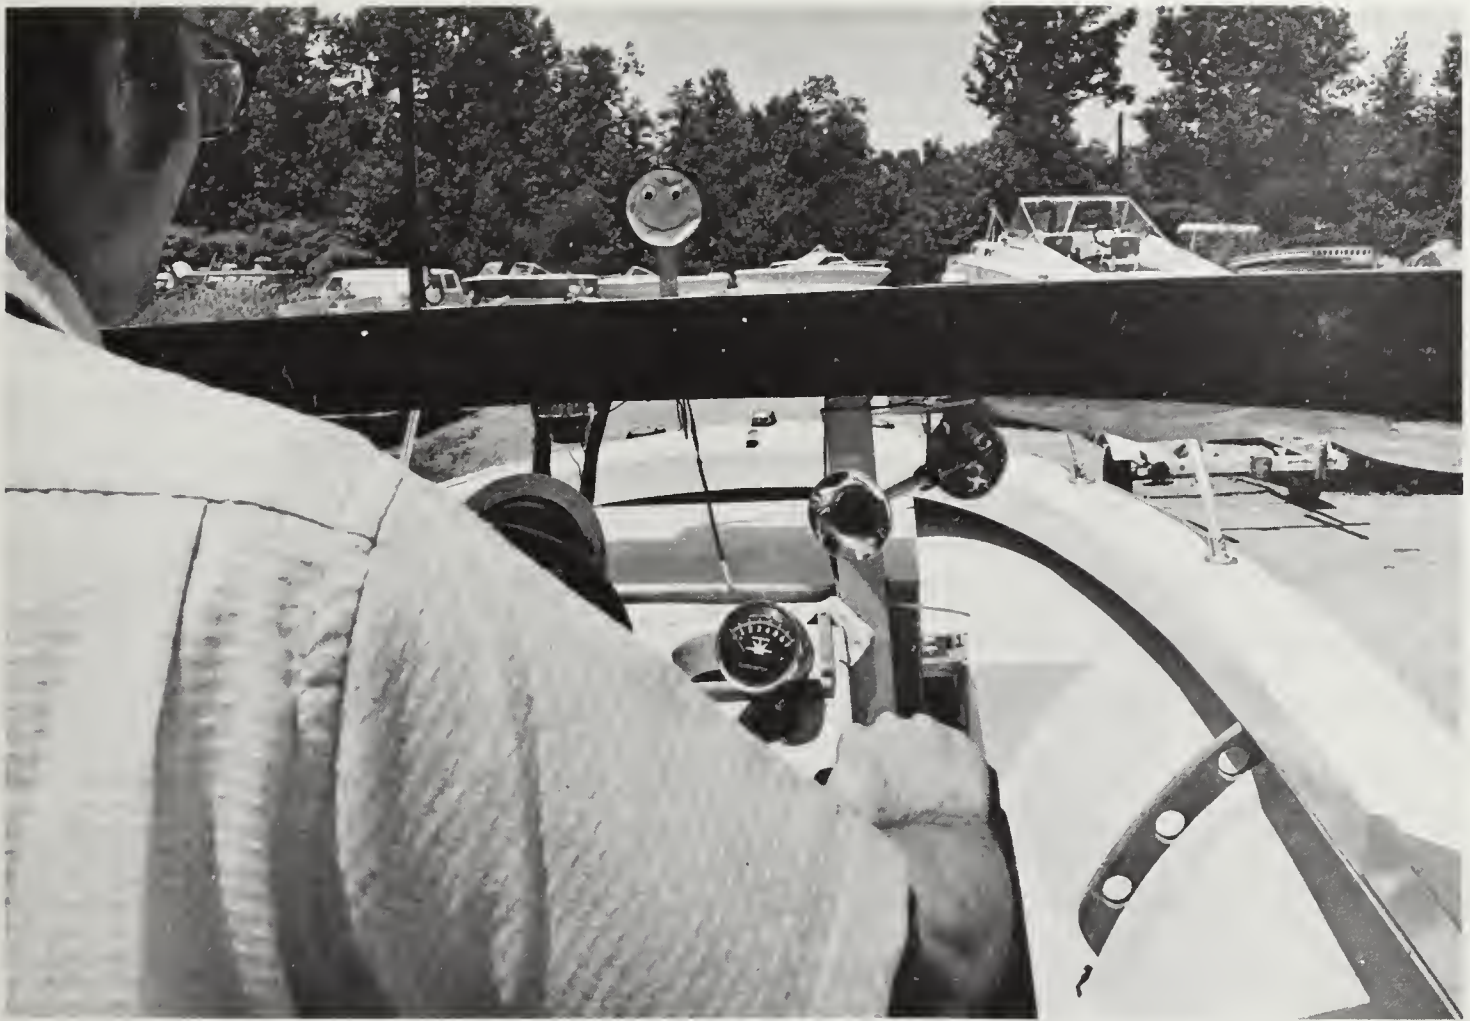
Figure 19. VAST Feedback Modifications

Several amendments to the apparatus and experimental design are needed to solve some of the problems that arose in Florida. Figure 19 shows one of these modifications.

The subject should be informed when he has responded correctly and when he has responded incorrectly. This will help him to learn faster and it will prevent him from deciding to respond to everything, in case what he saw might have been a steady light. Figure 21 shows a windshield washer arm mounted to the light display with a "reinforcing" stimulus attached. This arm would become visible when the minicomputer recognizes a correct response from the

subject. The arm would not be visible otherwise. When an incorrect response is made, the throttle handle would vibrate and buzz to signal the error. Thus, the subject will know about his performance as the test progresses.
